**TARGETED BROWNFIELDS ASSESSMENT
ASBESTOS CONTAINING BUILDING MATERIALS AND
LEAD-BASED PAINT INSPECTIONS**

**Paducah Palace Theatre
815 8th Street
Paducah, Cottle County, Texas 79248**

Report Date: June 11, 2012

dse Project N^o: 1037508

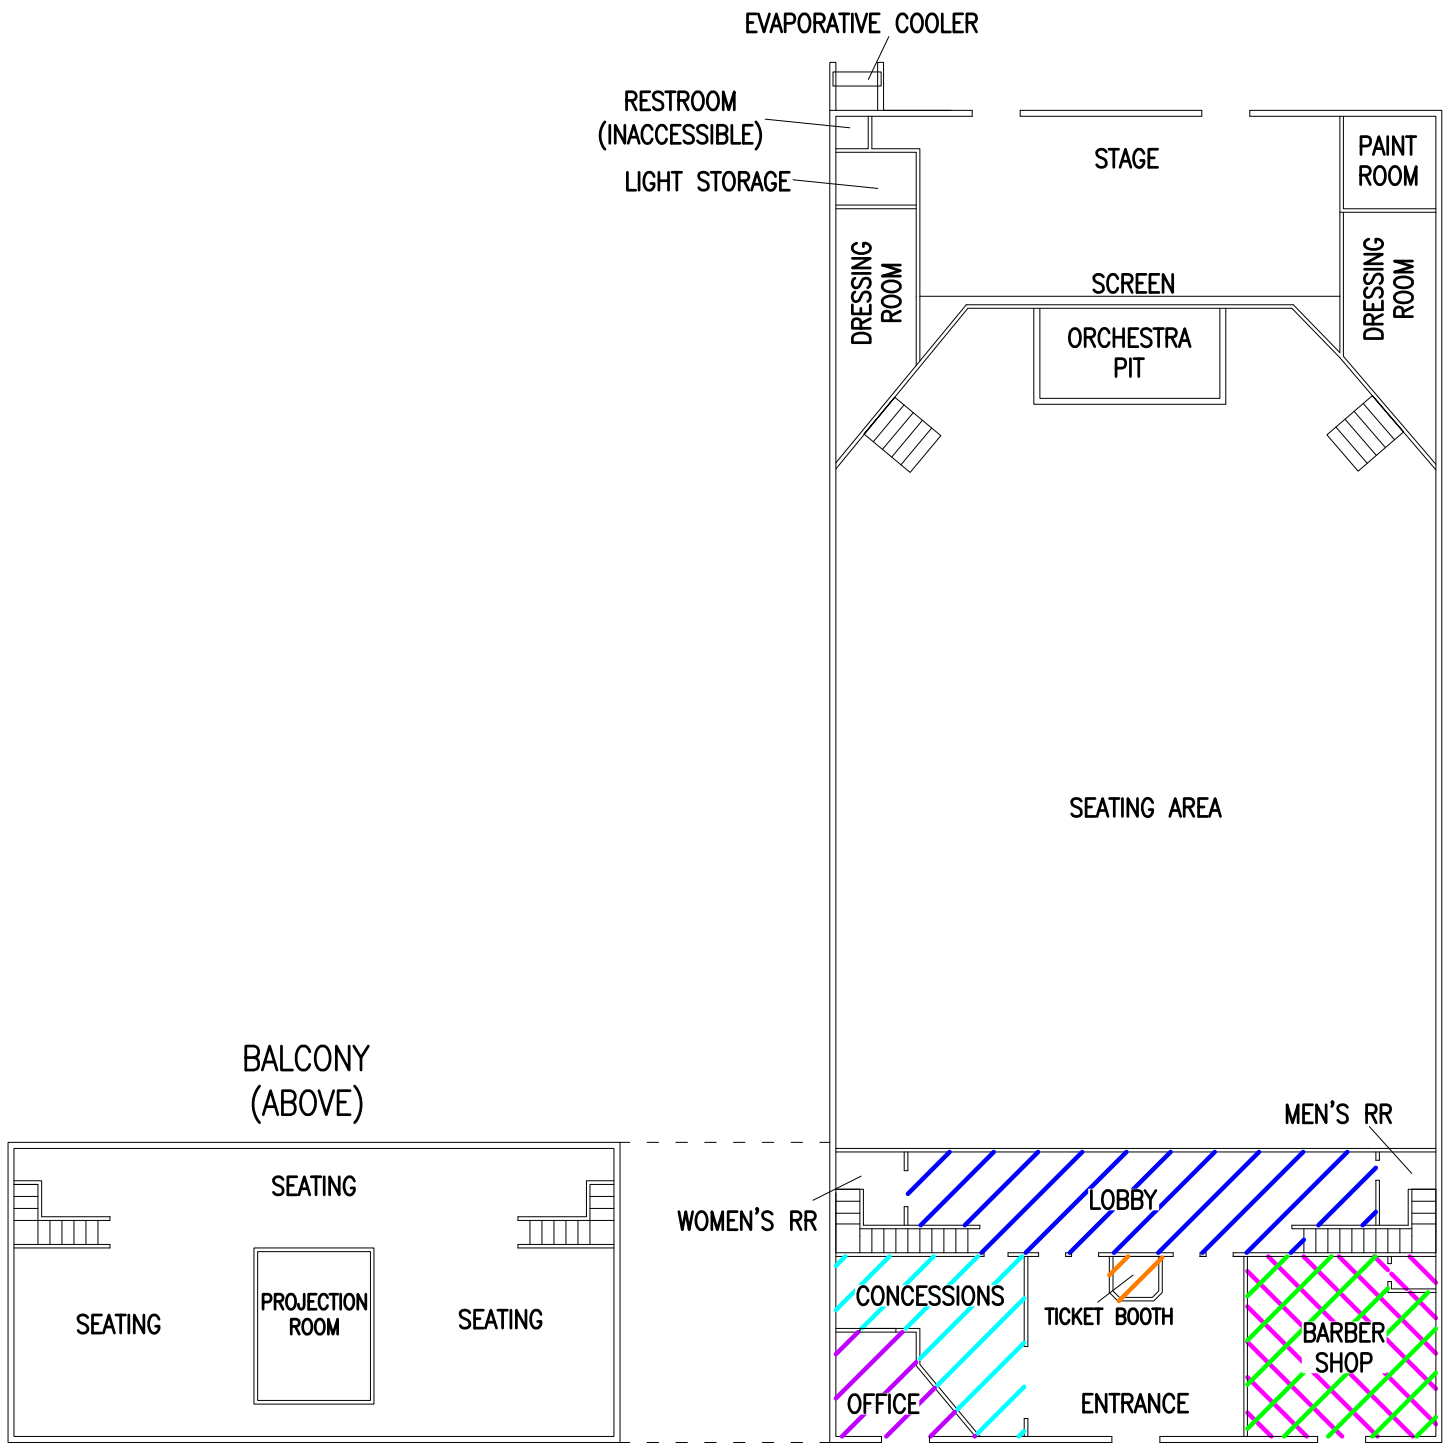
FIGURE 2
Identified Surfacing and
Miscellaneous ACBM Areas

-   12"x12" Olive VCT (3% Chrys.)/Black Mastic (5% Chrys.)
-   12"x12" White "Marble" VCT (3% Chrys.)/Black Mastic (5% Chrys.)
-   12"x12" Cream with "Marble" Chips VCT (5% Chrys.)/Black Mastic (5% Chrys.)
-   9"x9" Tan VCT (10% Chrys.)/Black Mastic (5% Chrys.)
-

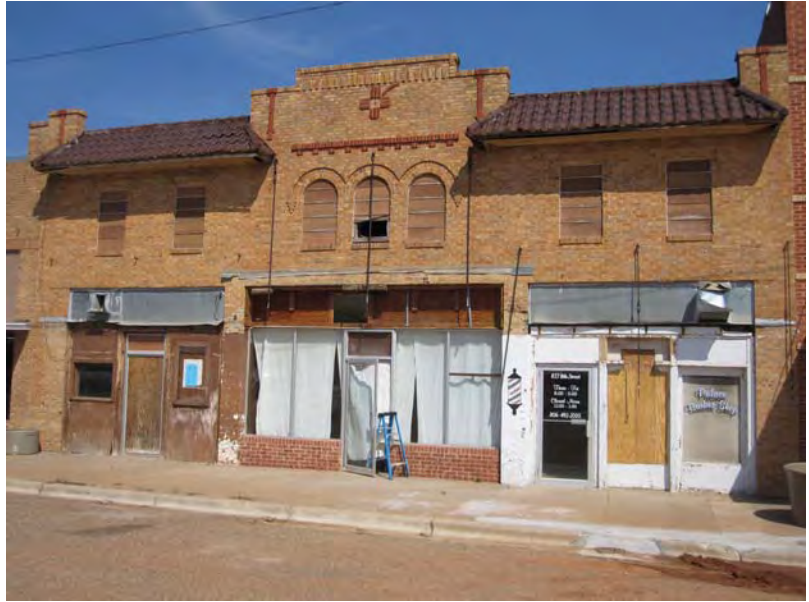
Exterior view of the front (west side) of the Paducah Palace Theater.

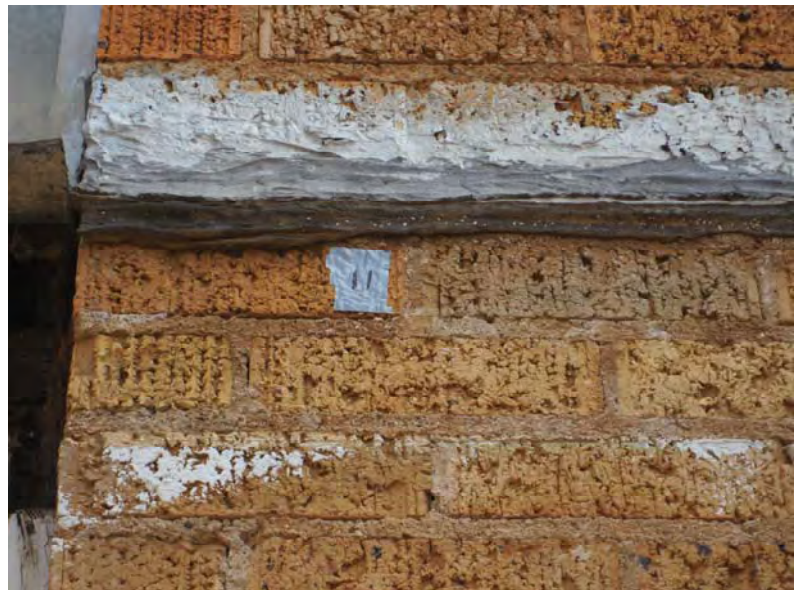
PHOTO 2 ►

Sample Location 11.
5% Chrysotile Asbestos in the
Silver Paint and Roofing Mastic,
3% in the Tan Caulking.

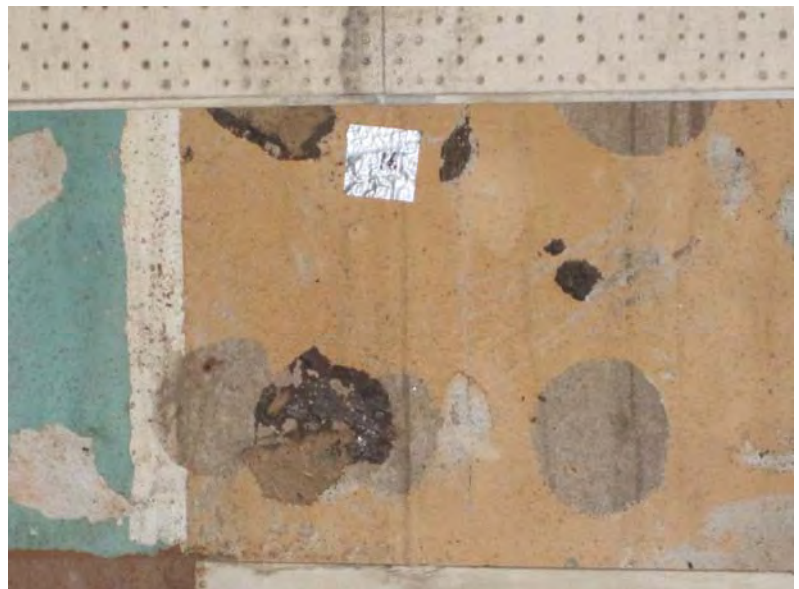
PHOTO 3 ►

Sample Location 16.
2% Chrysotile Asbestos in the
Acoustic Wall Panel Mastic.

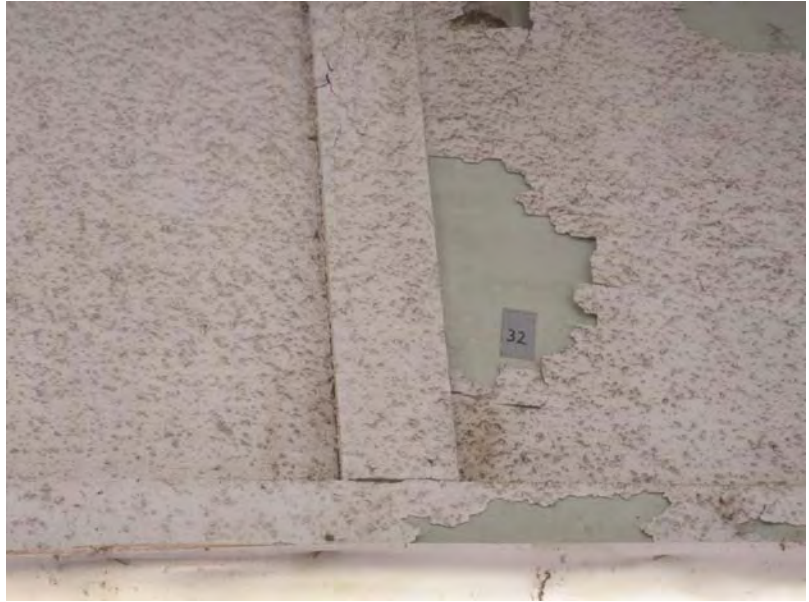
PHOTO 4 ►

Sample Location 32.
4.00% Chrysotile Asbestos in the
“Popcorn” Texture on the Ceiling
and Upper Walls of the entrance
Area.

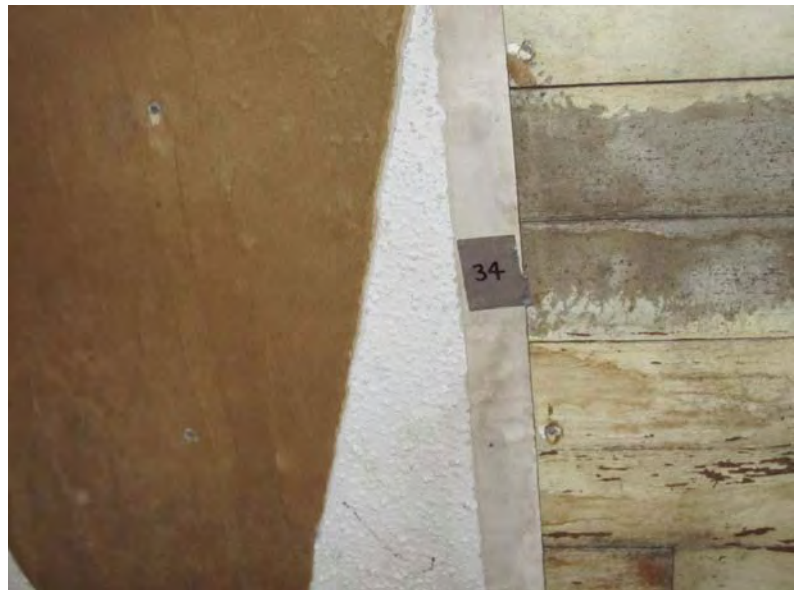
PHOTO 5 ►

Sample Location 34.
2.75% Chrysotile Asbestos in the
“Popcorn Texture” and 1.50%
Chrysotile Asbestos in the Joint
Compound on the Ceiling of the
Lobby.

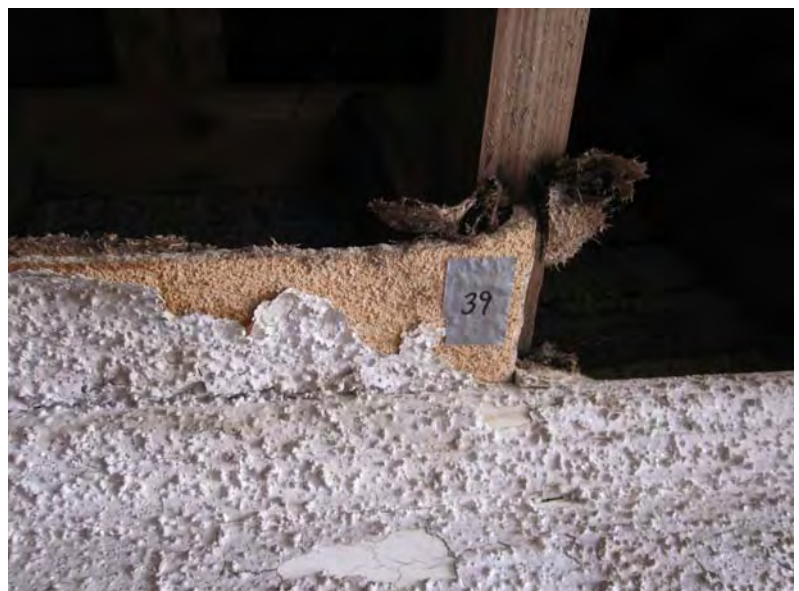
PHOTO 6 ►

Sample Location 39.
2.25% Chrysotile Asbestos in the
Popcorn Texture on the ceiling of
the Ticket Booth.

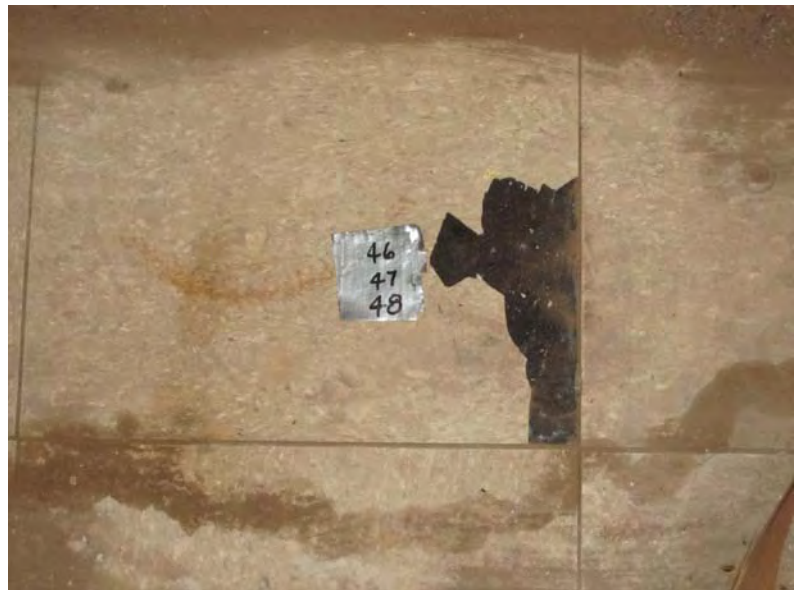
PHOTO 8 ►

47	8	12" x 12" Tan w/ Gray and Brown VCT and Mastic	Office Floor	M	NF	Significantly Damaged
48	8	12" x 12" Tan w/ Gray and Brown VCT and Mastic	Office Floor	M	NF	Significantly Damaged
49	9	12" x 12" Olive VCT and Mastic	Lobby Floor	M	NF	Significantly Damaged
50		12" x 12" Olive VCT and Mastic	Lobby Floor	M	NF	Significantly Damaged
51		12" x 12" Olive VCT and Mastic	Lobby Floor	M	NF	Significantly Damaged
52	10	9" x 9" Tan VCT and Mastic	Barber Shop Floor Bottom Layer	M	NF	Significantly Damaged
53		9" x 9" Tan VCT and Mastic	Barber Shop Floor Bottom Layer	M	NF	Significantly Damaged
54		9" x 9" Tan VCT and Mastic	Barber Shop Floor Bottom Layer	M	NF	Significantly Damaged
55	11	12" x 12" White Marble-Look VCT and Mastic	Barber Shop Floor Top Layer	M	NF	Significantly Damaged
56		12" x 12" White Marble-Look VCT and Mastic	Barber Shop Floor Top Layer	M	NF	Significantly Damaged

Sample Locations 46, 47 and 48.

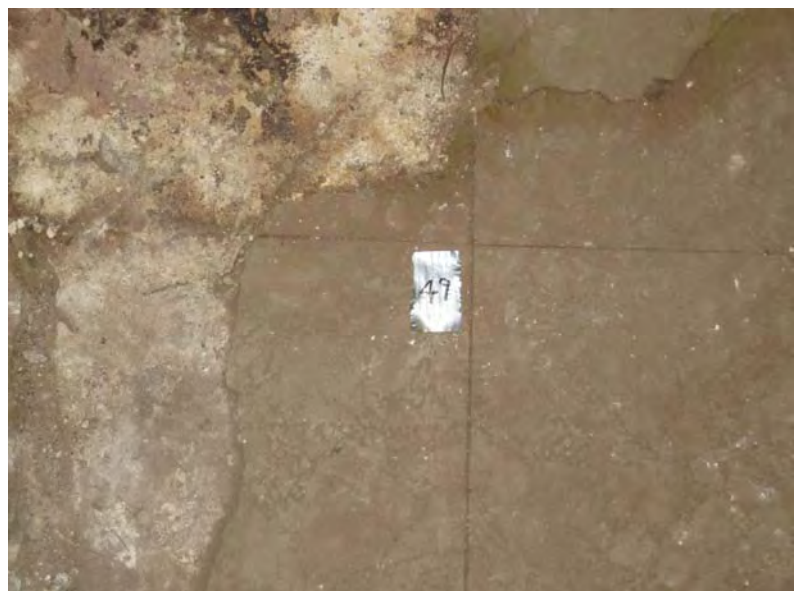
PHOTO 9 ►

Sample Location 49.

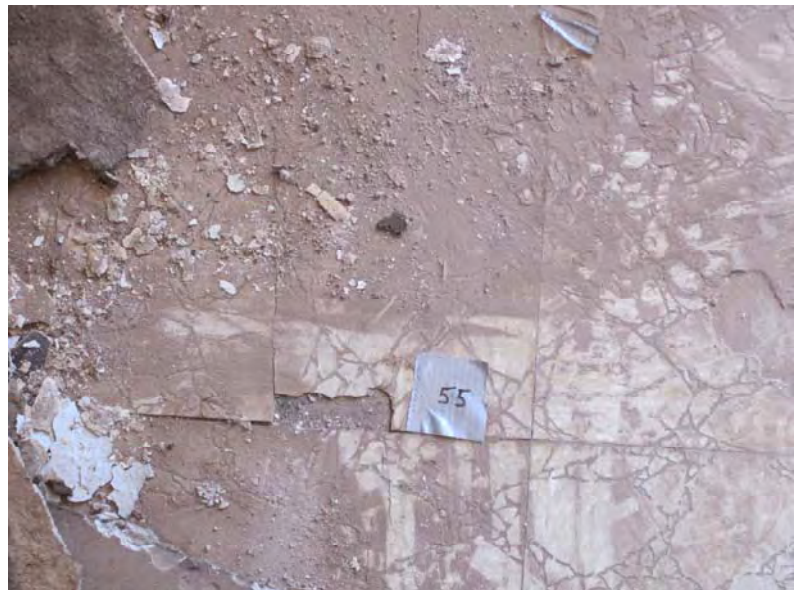
PHOTO 11 ►

Sample Location 55.

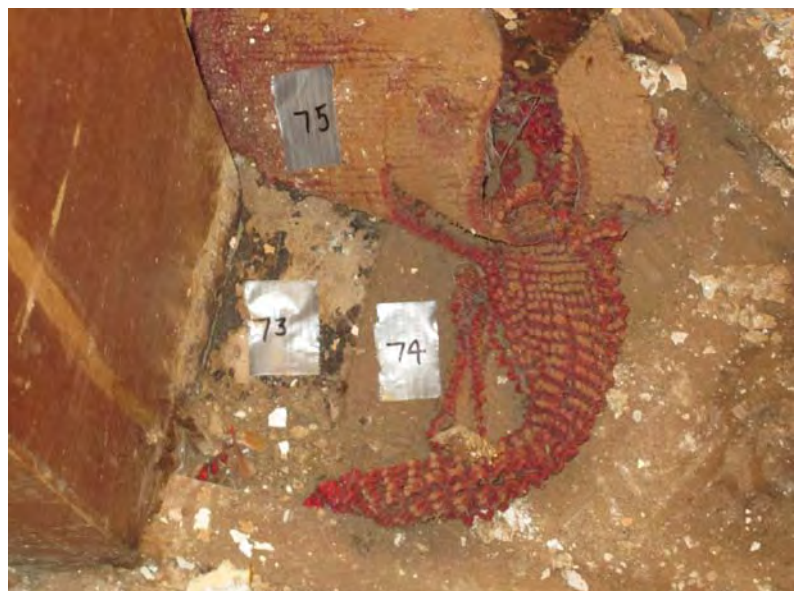
PHOTO 12 ►

75	12	12" x 12" Brown VCT and Mastic	Ticket Booth Floor	M	NF	Significantly Damaged
76		Brown Sheet Vinyl Flooring	Projection Room Floor	M	NF	Significantly Damaged

Sample Locations 73, 74 and 75.

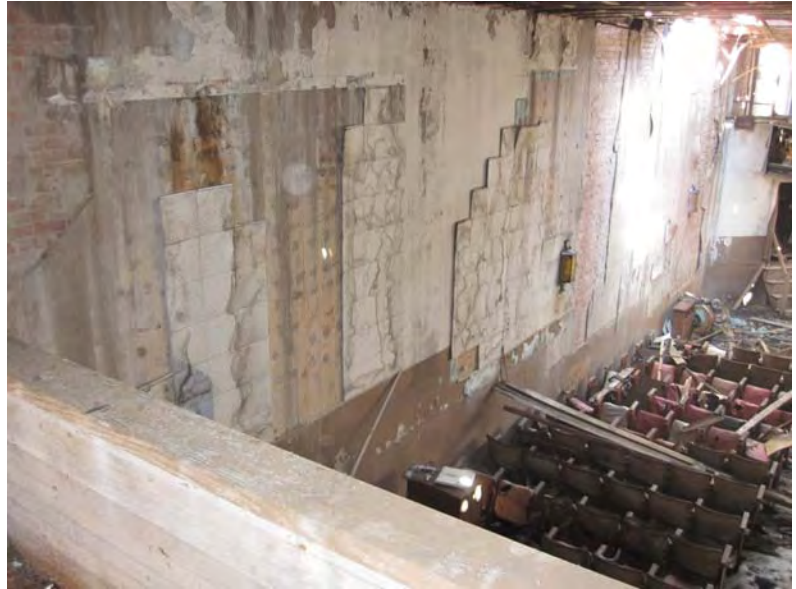
PHOTO 13 ►

A view of the North wall of the Seating Area showing the areas of 1' x 1' Acoustic Wall Tiles glued to the wall with asbestos-containing mastic.

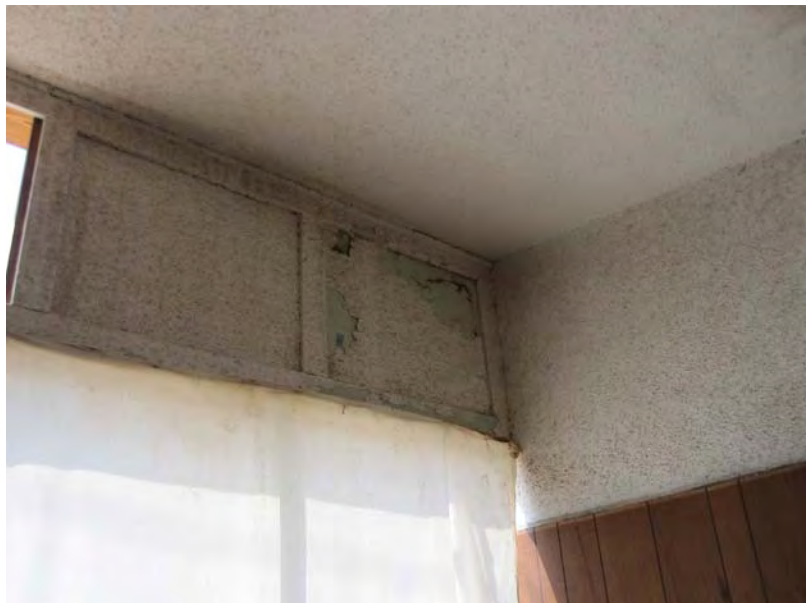
PHOTO 14 ►

A view of the Northwest corner of the Entrance Area showing the asbestos-containing “Popcorn” Texture on the ceiling and upper walls.

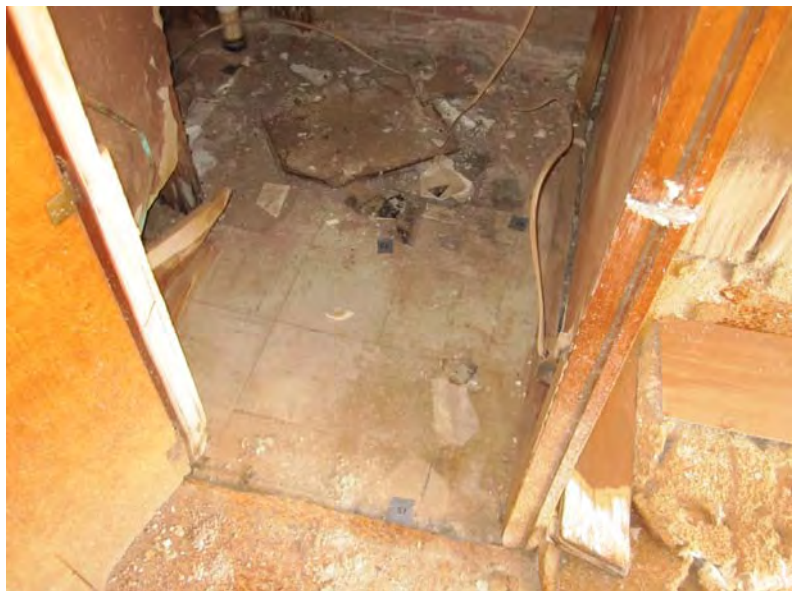
PHOTO 15 ►

A view of the closet of the Barber Shop showing the asbestos containing 9” x 9” VCT and Black Mastic flooring.
